BELZONA SEPARATES DISSIMILAR METAL PIPES

ID: 641

Customer Location: Offshore platform, UK
Application Date: October 2001

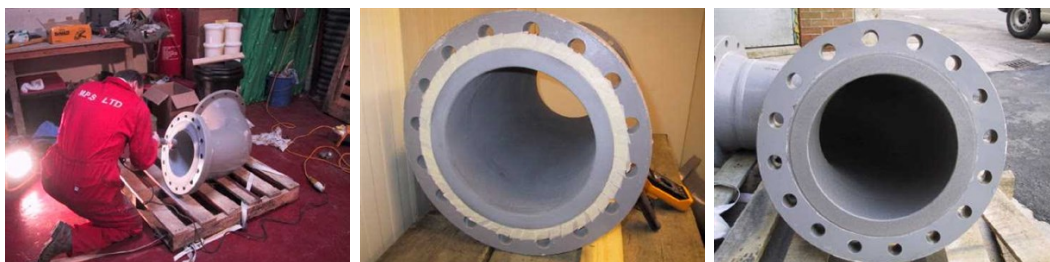
Photograph Descriptions

Galvanic corrosion between dissimilar pipe sections.

- * Surface Preparation ,
- * Pipe masked up ,
- * Finished Application ,

Pipe linings and flanges.

Application was carried out in accordance with Belzona Know-How System Leaflet VPF-2.

Belzona's electrical isolating properties form a barrier to the electrolytic cell set up by the dissimilar metal thus stopping galvanic corrosion. The previous vulcanized rubber coating had failed in less than 6 months. These repairs were still in service four years later.
