# BELZONA RESTORES CENTURY-OLD SHIP

ID: 6438

Customer Location: Dry Dock, Belfast, Ireland  
Application Date: October 2016

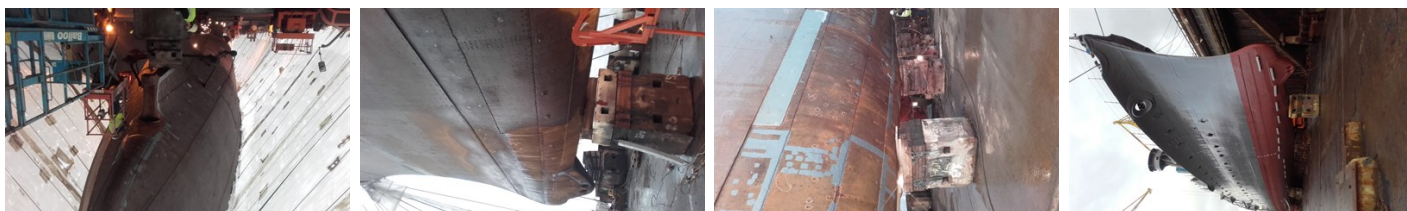
Numerous compartments, fuel tanks and storage areas below the waterline had been taking on water. Welding was limited to areas of the hull that had no leaks, and that were robust enough to withstand hot works. The client was looking for a long-term repair solution, capable of bonding to a poor substrate and with rapid cure times as the dry dock was already booked for another ship repair.

- \* 1. HMS Caroline in dry dock ,
- \* 2. Hull in need of leak sealing ,
- \* 3. Cold-applied, fast-curing solution administered ,
- \* 4. Hull after repairs and coating ,

The application was carried out in accordance with Belzona System Leaflet SOS-1. Due to the size of the project and the short working window, a team of Mixers, Runners and Applicators were utilised. Belzona 1111 was firstly used to fill in badly corroded areas. The poor substrate condition in some areas required a surface-tolerant solution, therefore, Belzona 1212 was used in these.
