PLAYGROUND DECKING MADE SAFE WITH BELZONA

ID: 6456

Customer Location: Primary School, Cleveland, UK
Application Date: 2016

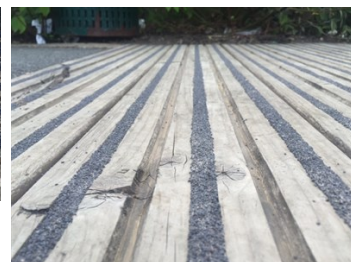
Wooden decking areas in the playground became very slippery in certain conditions. There had been an injury claim against the school so they wanted to retro-fit a grip system to make it safer for the children.

- * 1. Playground overview ,
- * 2. Applying the Belzona 5811/9211 mixture ,
- * 3. Blinding with Belzona 9211 Supergrip ,
- * 4. Detail of completed Application ,

The application was a modified version of Belzona system leaflet FPA-8. Belzona 9211 was incorporated into the Belzona 5811 and injected along selected grooves before being blinded with more aggregate.
