FORMATION OF LOW PROFILE OIL CONTAINMENT TRAPS WITH BELZONA

ID: 660

Customer Location: Mobile machinery manufacturer, Wales
Application Date: Ongoing since 1995

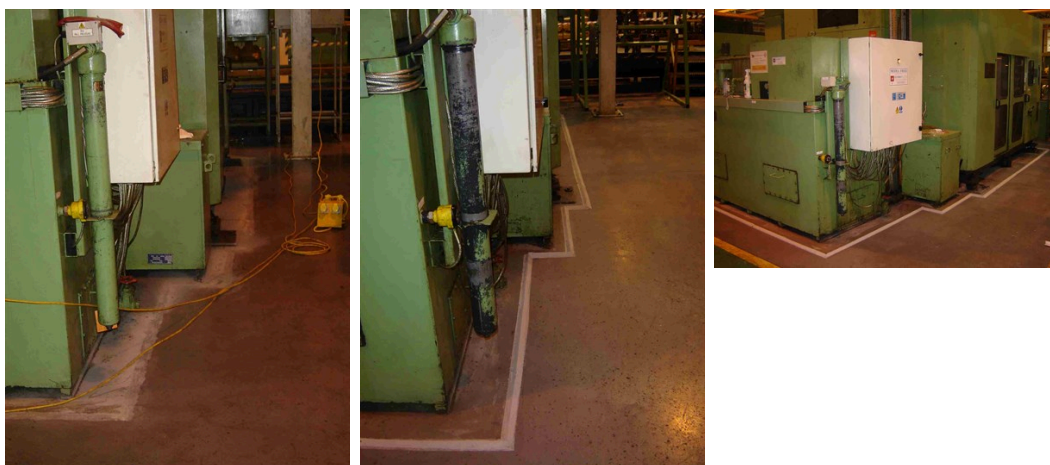
Photograph Descriptions

The problem is leaking oil (or chemicals) from machinery which seeps/spills/runs across the floor and into pedestrian walkways. This causes problems from both an environmental standpoint and also safety as oily floors equals slip hazards(multiplied by its proximity to machinery).

- * Agreed area around machinery prepared ,
- * Pipe removed Belzona® 4111 trap formed ,
- * Finished job neat and effective ,

The area where the containment trap is to be created is carefully chosen so as not to create a potential trip hazard. The application is carried out in accordance with a modified version of Belzona Know-How System Leaflet TCC-9. Two-inch plastic pipe sections, cut in half length wise are used to form the Belzona® 4111 containment dam.
