# BELZONA PROTECTS 10,000 SQUARE FEET OF FLOORING

**Industry:** Chemical & Petrochemical  
**Application:** TCC-Tanks and Chemical Containment Areas  
**Substrate:** Concrete  
**Products:** \* Belzona® 5811 (Immersion Grade),  
\* Belzona® 2131 (D&A Fluid Elastomer),

**Customer Location:** Chemical Plant in Alabama  
**Application Date:** December 1996

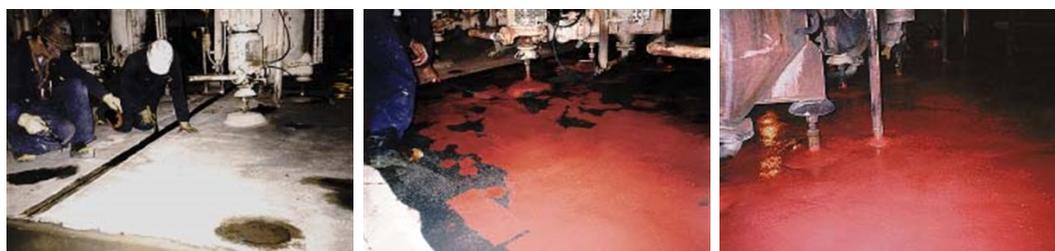
- \* Bridging over expansion joint in accordance with modified Belzona application procedure TCC-12 with Belzona® 2131. ,
- \* First coat of Belzona® 5811 applied with Belzona® 9221 (Surefoot Aggregate White) broadcast for non-skid safety system. Application of second coat Belzona® 5811 (tinted red) in progress. ,
- \* The completed application, floor and ground protected from chemical degradation and contamination. ,

The chemical plant needed to prevent mercury from entering the ground through the concrete containment. The situation was aggravated by 50% KOH (potassium hydroxide) that was attacking the concrete and expansion joint sealant.

The application was carried out in accordance with Belzona Know-How Leaflets TCC-12 and TCC-15.
