BELZONA REPAIRS ASH SCREW CONVEYOR BEARINGS

Customer Location: *Cement Works, Usje, Macedonia*
Application Date: *September 2004*

Substrate: *Steel*
Products: ** Belzona® 1131 (Bearing Metal),*

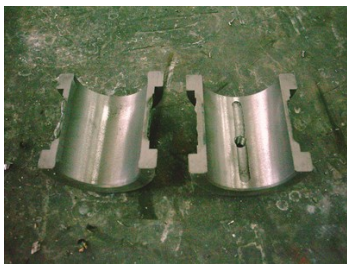
- * Application situation ,
- * Worn friction bearing ,
- * Repaired bearings ,
- * Finished application ,

Friction Bearings on Ash Screw Conveyor

Application was carried out in accordance with Belzona Know-How System Leaflet MPT-9.

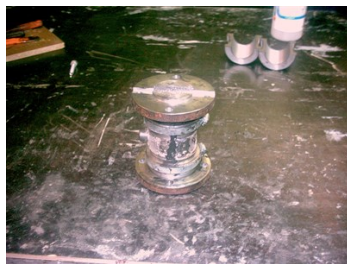
Severe wear due to dusty working environment.

The bearings were made of grey iron and were lasting just 3-4 weeks. Following the application of Belzona® 1131 the bearings were lasting 3-4 months thus saving down time as the bearings needed replacing less often.
