# BELZONA REPAIRS ASH SCREW CONVEYOR BEARINGS

ID: 690

Customer Location: *Cement Works, Usje, Macedonia*  
Application Date: *September 2004*

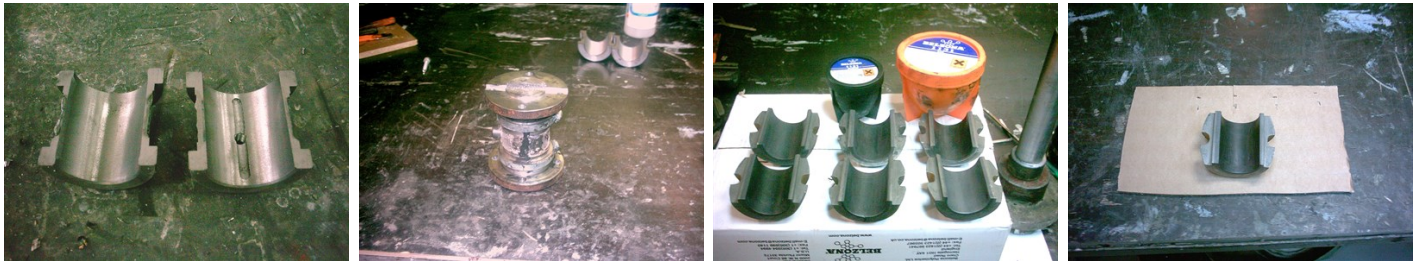
## Photograph Descriptions

*Severe wear due to dusty working environment.*

- \* Application situation ,
- \* Worn friction bearing ,
- \* Repaired bearings ,
- \* Finished application ,

Friction Bearings on Ash Screw Conveyor

Application was carried out in accordance with Belzona Know-How System Leaflet MPT-9.

The bearings were made of grey iron and were lasting just 3-4 weeks. Following the application of Belzona® 1131 the bearings were lasting 3-4 months thus saving down time as the bearings needed replacing less often.
