# BELZONA PROVIDES LONG TERM PROTECTION IN HIGH TEMPERATURE SULPHUR

Industry: Oil & Gas  
Application: VPF-Valves, Pipes and Fittings  
Substrate: Carbon Steel  
Products: \* Belzona® 1591 (Ceramic XHT) ,

Customer Location: Oil Refinery, United Kingdom  
Application Date: 1997

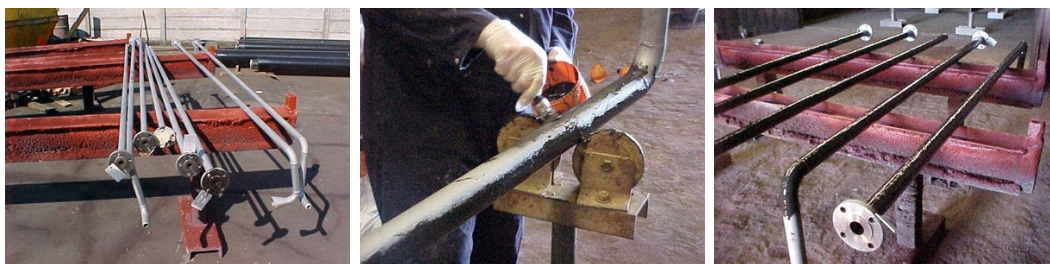
Sulphur at 118-128°C was causing high levels of corrosion.

- \* Pipes ready for application ,
- \* Brush application of Belzona® 1591 ,
- \* Coated pipes ,

Application was carried out in accordance with Belzona Know-How System Leaflets VPF-2.

Initial application was done as a test. This application was still performing well four years later to the customers shock and delight. Since this initial application lids, pipework, viewports, manways, coil legs and pump externals have all been coated.
