40 PROCESS VESSELS LINED WITH BELZONA FOR NEW OIL & GAS PROJECT

ID: 7470

Application: TCC-Tanks and Chemical Containment Areas

Customer Location: Major oil company, Iraq

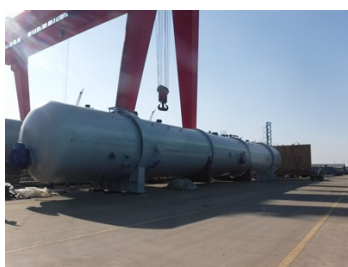
- * 1. Overview of 120K desalter ,
- * 2. Coating application ,
- * 3. Belzona inspector is doing final inspection with client. ,
- * 4. Application completed ,

The application was carried out in accordance with Belzona Know-How System Leaflets TCC-5, TCC-16a and TCC-16b. Vessels were internally lined with two coat system of Belzona 1391T. Small bore nozzles were fully protected by glueing in preformed Belzona 1111 nozzle inserts. All vessels were coated at the fabricator yards in China before shipment and installation on site.
