COLD BONDING PIPE SUPPORTS WITH BELZONA

ID: 7476

Customer Location: Refinery, Shaanxi, China
Application Date: March 2017

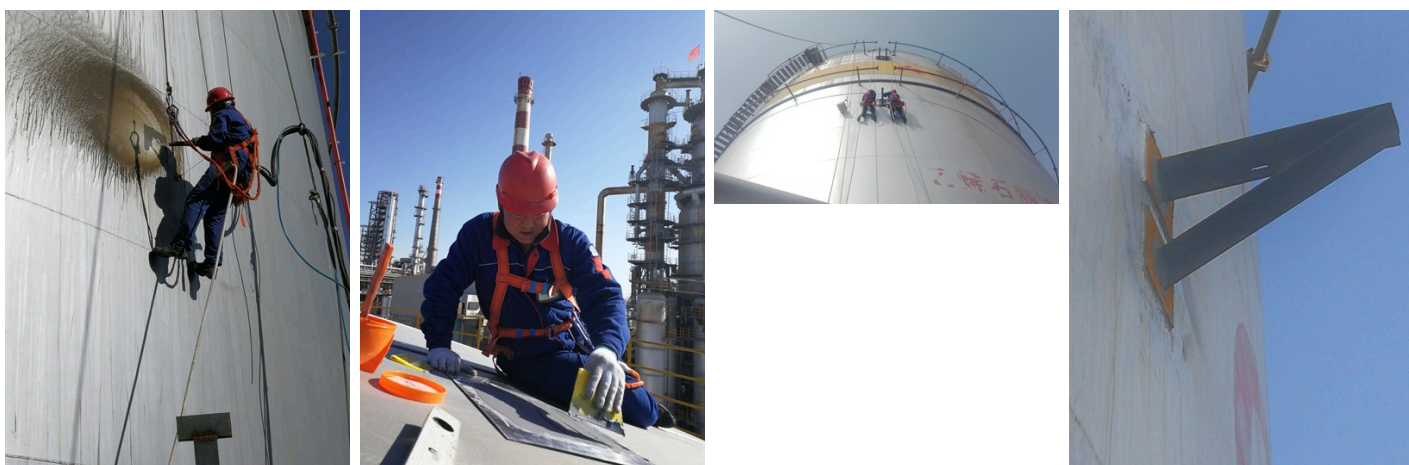
Photograph Descriptions

- * 1. Water jet blasting for surface preparation ,
- * 2. Application on top of the tank ,
- * 3. Application on tank wall in process ,
- * 4. Application completed ,

The application was carried out in accordance with Belzona Know-How System Leaflet TCC-6 and VPF-15. To ensure optimum bond whilst observing the safety requirements in the tank farm, surface preparation was conducted using water jet blasting equipment.
