BELZONA PROVIDES ANTI-SLIP ON PAPER MILL DRIVE DRUM

ID: 7492

Industry: *Pulp & Paper*
Application: *SHM-Solids Handling Machinery*

Customer Location: *Paper producer, Poland*
Application Date: *2011*

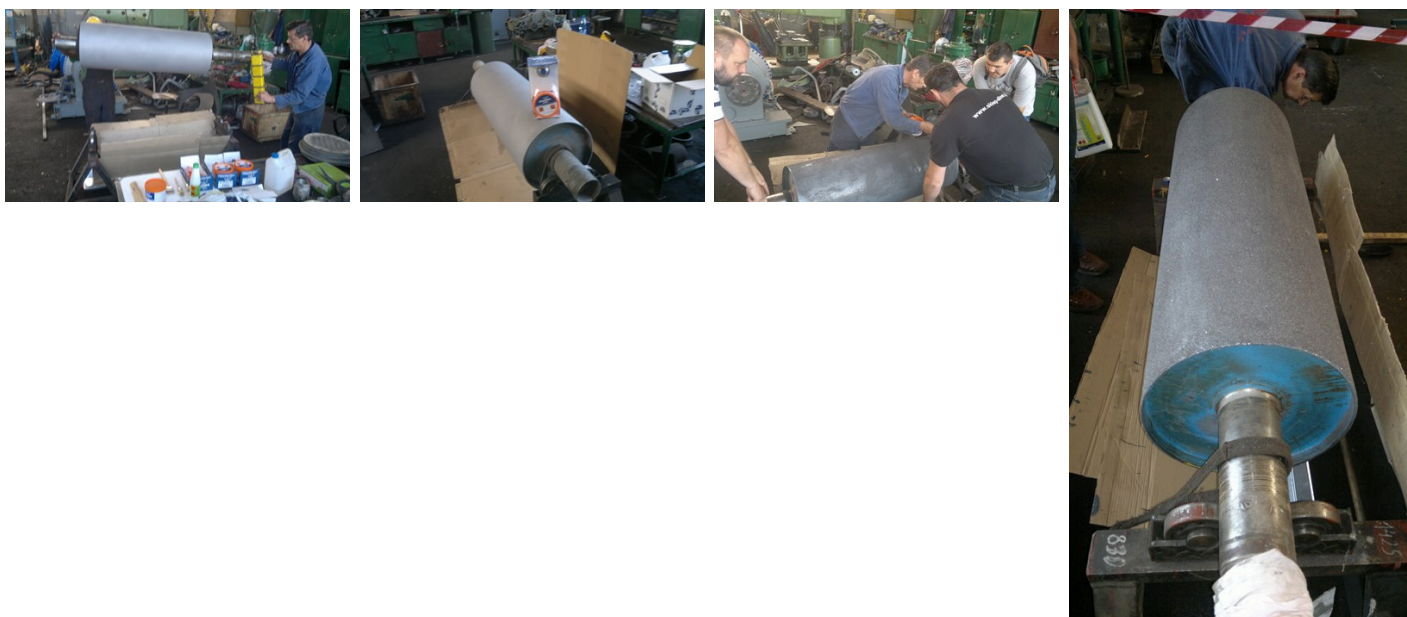
Previous anti-slip surface had worn away and an improved, long-lasting surface was required.

- * 1. Drum after surface preparation ,
- * 2. Applying Belzona 1321 ,
- * 3. Incorporating Belzona Aggregate ,
- * 4. Finished Application ,

Drive drum from paper production.

Application was carried out in accordance with Belzona System Leaflet SHM-12. The surface was prepared by grit blasting followed by coating with Belzona 1321 and incorporating Belzona 9211 Supergrip aggregate.

The Belzona solution provided superior 'grip' properties that will increase the efficiency of production at the mill.
