# BELZONA TANK BASE SEAL STILL GIVING SUPERB PROTECTION

ID: 7544

**Customer Location:** Petrochemical Plant, UK  
**Application Date:** 2010

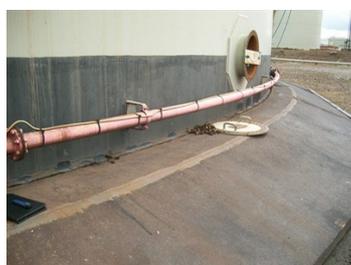
Over the years the bitumen and sand base under this 36m diameter tank had compressed, to such an extent that the annular rim was now at least 10mm below the surrounding concrete plinth. Water was actually being captured at the rim which had dramatically increased the risk of under base corrosion. Various mastics had been tried in the past, but all failed quickly.

- \* 1. Initial condition of tank. ,
- \* 2. Annular rim creating channel for water. ,
- \* 3. Tank Base Seal application in 2010. ,
- \* 4. Tank revisited in 2017. ,

For many years this customer had recognised the long-term benefits of using the Belzona Tank Base Sealing system. After reprofiling the plinth, the Belzona Tank Base Seal was installed around the full diameter, preventing any risk of water ingress to the base. The work was inspected again in 2017 and is still in perfect condition. To date this client has protected over 50 tanks with the Belzona Tank Base Seal solution.
