BELZONA PROTECTS THE SURFACE OF MAIN WATER-PUMP INLET MANIFOLD

ID: 7556

Customer Location: *Mining Company, Norway*
Application Date: *September - October, 2017*

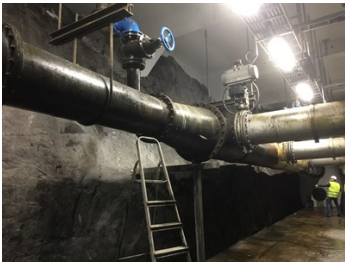
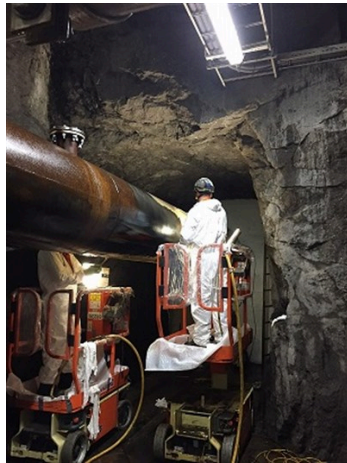
Photograph Descriptions

Severe corrosion on these pipes externals had developed over 50 years, several unsuccessful attempts to protect the pipe had been started and ended without fully protecting the surface over the last 10 years. Humidity of 100%, constant running water from the surface and no possibility to gritblast meant conditions were not ideal for a coating application.

- * 1. Overview of wet and condensed pipe manifold. ,
- * 2. Surface preparation and first coat application ongoing. ,
- * 3. First coat applied. ,
- * 4. Final coat applied and cured. Constant running water from the surface can be seen. ,

Corrosion on a 50 year old inlet manifold at the bottom of an 80 metre deep column in an Ilmenite factory.

Application was carried out in accordance with a modified version of Belzona Know-How System Leaflet CEP-4. Manual surface preparation was carried out using a combination of different tools. Belzona 1212 was used to fill deep pitting in the surface. Then, Belzona 5831 was applied for corrosion protection.

The Belzona surface-tolerant products were the only option considered for this application due to the humid conditions and constantly wet surface in the work area. The drying out of the application area would be very cost and time consuming. 80 sqm of pipe surface was completed successfully as planned in 9 working days.
