COOLING TOWER COATED WITH BELZONA® 5811 BY SPRAY

ID: 761

Industry: *Buildings & Structures*
Application: *HEX-Heat Exchangers*
Substrate: *Galvanized Steel*
Products: *Belzona® 5811 (Immersion Grade)*

Customer Location: *Automotive Plant in Southern Ontario*
Application Date: *February, 2006*

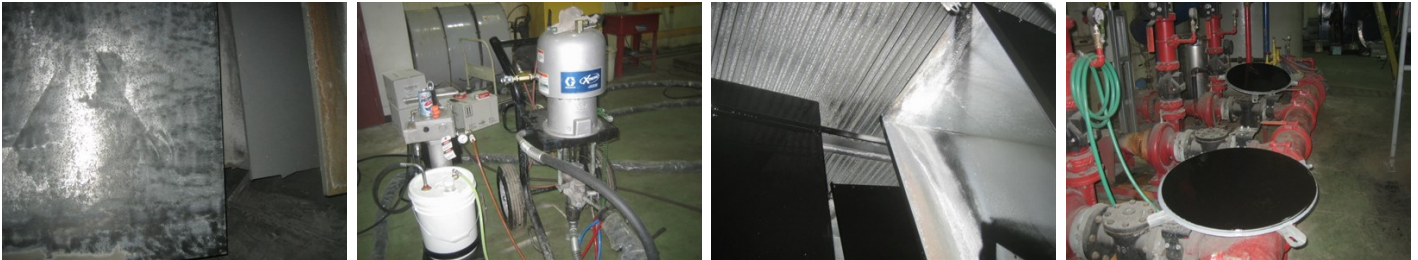
Photograph Descriptions

Previous coating was coming off before going into service.

* Previous coating easily blasted off. , * Application Pump made ready. , * Material spray applied to 700 square feet very quickly. ,
* Door closures were also coated and job completed. ,

Application was carried out in accordance with Belzona Know-How System Leaflet HEX-12. Spray applied with Graco Extreme 68-1 Pump and heated lines with Viscon heater.
