# Belzona Spin Spray Applied Protective Coating for Scraper Traps

ID: 7681

Industry: Oil & Gas  
Application: VPF-Valves, Pipes and Fittings  
Substrate: Carbon steel  
Products: \* Belzona 1391S ,

Customer Location: Oil Field, Saudi Arabia  
Application Date: 2017 - 2018

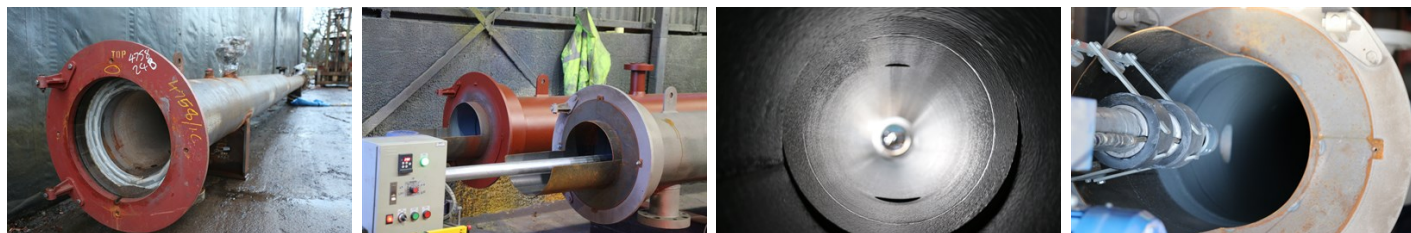
- \* 1. Scraper trap prior to application. ,
- \* 2. Calibration. ,
- \* 3. First coat applied. ,
- \* 4. Application complete. ,

Application was carried out in accordance with Belzona Know-How System Leaflet VPF-2 using spin spray application equipment.
