OLD PUMPS REPAIRED, PROTECTED AND IMPROVED WITH BELZONA

Industry: Marine
Application: CEP-Centrifugal Pumps
Substrate: Cast Iron
Products: * Belzona 1121 ,
* Belzona 1341 ,

Customer Location: Dry Dock Facility, BC, Canada
Application Date: August 2017

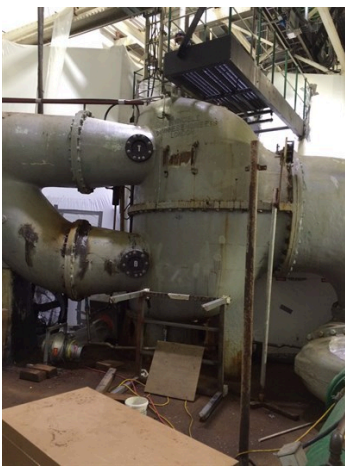
- * 1. 30 ft high pump. ,
- * 2. Showing damage from erosion-corrosion. ,
- * 3. Application of Belzona 1341 Blue in progress. ,
- * 4. Complete application. ,

Pumps housing building at a Canadian historic site. 30 ft high pumps.
