Belzona 3211 Used for Fuel Pipeline Insulation inside Engine Room

ID: 7728

Industry: *Marine*
Application: *TCC-Tanks and Chemical Containment Areas*
Substrate: *Stainless-steel*
Products: *Belzona 3211 (Lagseal),*

Customer Location: *Croatia, Marine*
Application Date: *January 2003*

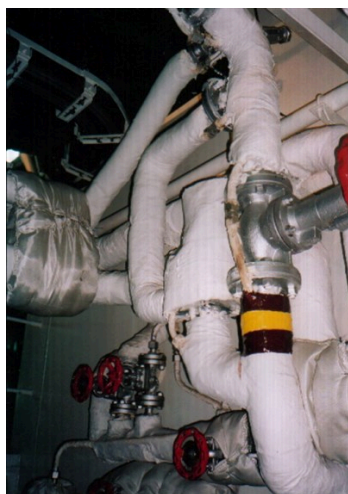
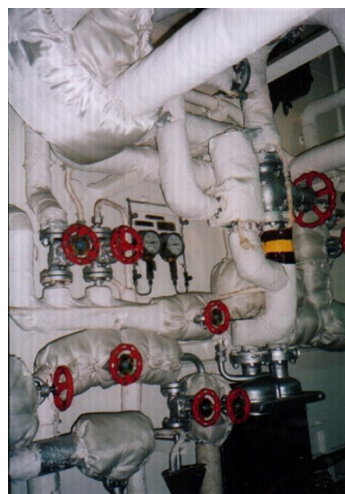
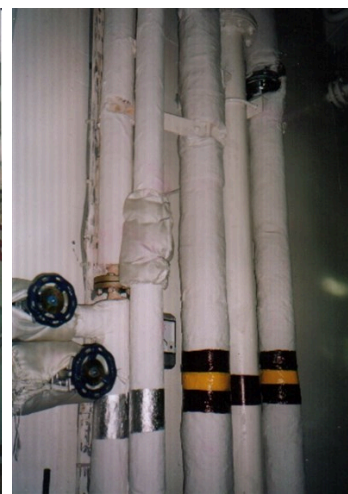
Insulation on various complex geometries required waterproofing. Other solutions considered for this application were rejected due to Health & Safety concerns.

The application took place in Rijeka shipyard, Croatia, on two newly built vessels - a Whitefin Shipping Chemical Tanker and a Gibraltar Chemical Tanker.

The application was carried out in accordance with Belzona Know-How System Leaflet TCC-4.

Belzona 3211 is weather and fire resistant, and conforms to the requirements for 'Class A' in accordance with 'ASTM E84'. It would not add to a fire and also would not create poisonous gases in case there was ever a fire.
