# Belzona 3111 to Waterproof a Stunning New Build Development

ID: 7742

Industry: *Buildings & Structures*  
Application: *RPA-Roof Problem Areas*  
Substrate: *Concrete*  
Products: *\* Belzona 3111 (Flexible Membrane) ,*

Customer Location: *Paris, France*  
Application Date: *July 2018*

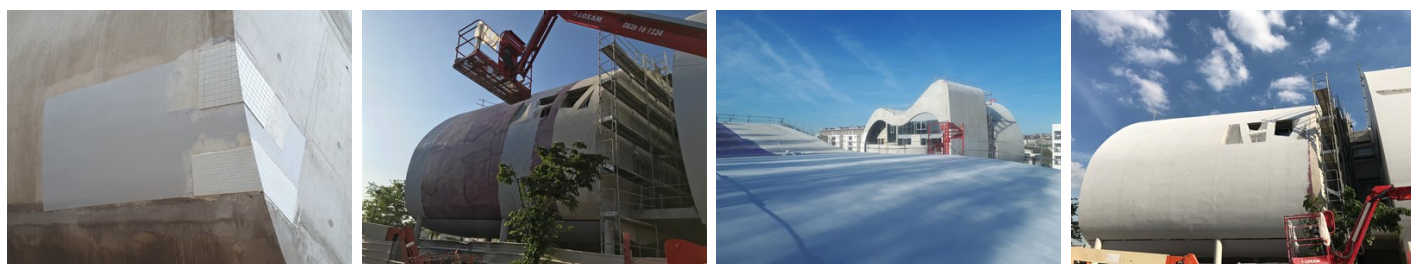
- \* 1 - A close up of the Belzona 3111 with the tiles bonded on top ,
- \* 2 to 4 - Application in progress ,

Belzona 3111 was rolled onto the roof to completely encapsulate it. Then it was overcoated with an adhesive to bond the tiles.
