BELZONA 5122 CLADDING PROTECTS A BRICK AND MASONRY STRUCTURE AT A UNIVERSITY BASEBALL STADIUM

Industry: *Buildings & Structures*
Application: *WPA-Wall Problem Areas*
Substrate: *Concrete, Brick and Rough Cut Cinder Block*
Products: ** Belzona 5122 (Clear Cladding) ,*

Customer Location: *Oregon, USA*
Application Date: *September, 2018*

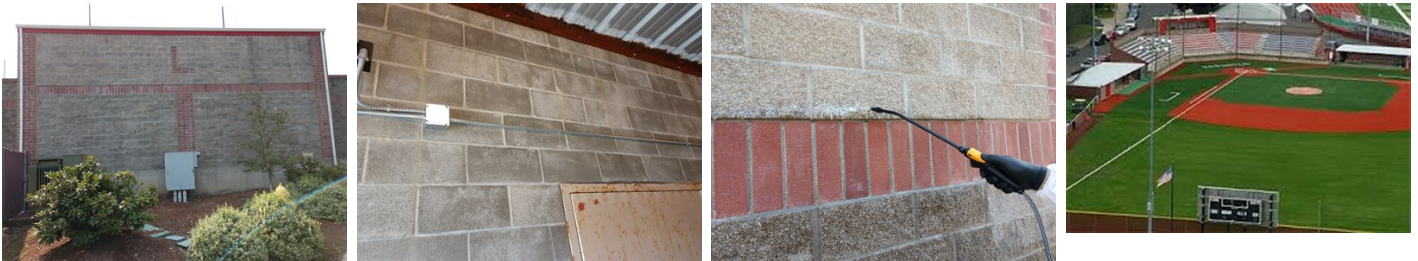
Photograph Descriptions

The structure needed to be protected from water ingress and water penetration, as the water penetrating inside was corroding metal components of these electronic systems, threatening their operation. The University had used Belzona 5122 on other buildings in the past and had confidence that Belzona could fix the problem while retaining the original aesthetics of the stadium.

- * The wall needing protection from water penetration ,
- * Corrosion had begun to degrade the internals and threatened damage to electronics ,
- * Application of Belzona 5122 ,
- * Stadium protected and ready for the games ,

Belzona 5122 was applied in accordance to WPA-8 Belzona Know-How System Leaflet. The surface was pressure washed to remove algae, moss, and dirt and allowed to dry. Belzona 5122 was then mixed and put into a standard garden sprayer. Belzona 5122 solution was then sprayed via the garden sprayer to the concrete, cinder blocks, and brick from the bottom up allowing excess to flood the previously coated areas.

Belzona 5122 provides a long term water repellent system for the concrete, brick and cinder block masonry. The coating system dries invisibly so it does not change the appearance of the structure. It also creates a self-cleaning surface that aids in keeping the building free of dirt, moss and algae production. This treatment will help ensure games go off without a hitch for years to come.
