BELZONA ELASTOMER SEALS CHAIN PLATE CASING ON NEW YACHT

ID: 776

Chain plate casings on a new luxury yacht under construction

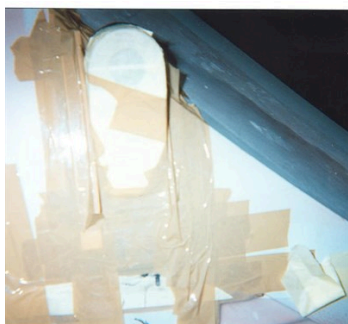
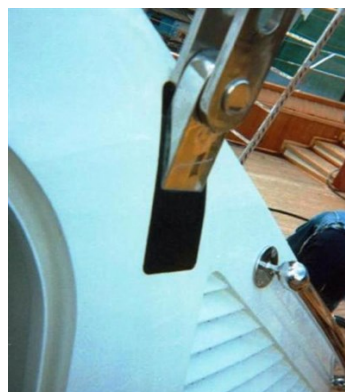
At late stage in construction it was realized that the design of the chain plate location into the superstructure would allow water ingress.

- * Tape used to contain Belzona during the pouring operation ,
- * The chain plate pocket sealed with Belzona® 2131 ,
- * Close up showing neat Belzona seal created ,

Application was carried out in accordance with Belzona Know-How System Leaflet GSS-4. As the application was partly vertical, tape was used to create a dam to enable the Belzona Elastomer to be poured into place.

It was not possible to change the design of the chain plate location into the superstructure so the Belzona solution was the only option available to ensure this location remained watertight.
