# Belzona repairs and protects the roof of a glass factory

ID: 7775

Application: RPA-Roof Problem Areas

Substrate: EPDM membrane

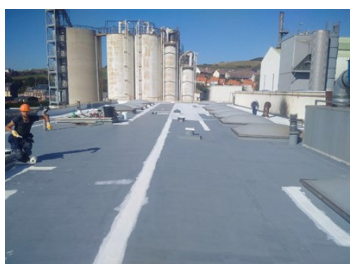
- \* 1. First step of the application using reinforcement sheets impregnated with Belzona 3111 on welds and junctions of the original EPDM membrane ,
- \* 2. First coat - Hand applied ,
- \* 3. Second coat - Spray applied ,
- \* 4. Final application ,

The whole roof surface was pressured washed, then Belzona 3111 was used with reinforcement sheets on the welds and junctions of the original EPDM membrane. After ensuring that all potential problem areas were encapsulated, a two coat system of Belzona 3111 was applied over the whole roof. The first coat was hand applied and the second one applied with an airless spray gun. In accordance with Belzona system leaflet RPA-01
