# BELZONA REBUILDS AND PROTECTS HEX END BELL AND CAP AT A BEVERAGE FACILITY

Application: *HEX-Heat Exchangers*

HEX end bell and cap at a juice manufacturing facility.

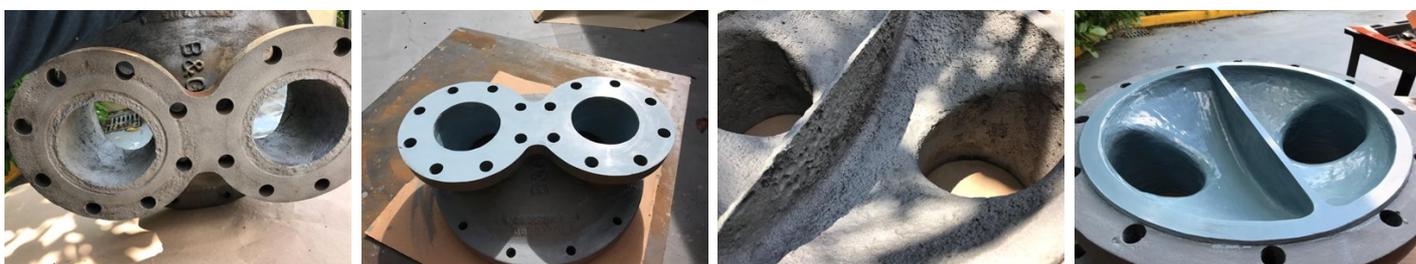
*Erosion-corrosion wear caused by having no protective coating before the heat exchanger started its service life.*

- \* End Cap after abrasive blasting ,
- \* End Cap after application of Belzona 1511 and 1391T ,
- \* End Bell after abrasive blasting ,
- \* End Bell after application of Belzona 1511 and 1391T ,

The application was carried out in accordance with modified versions Know-How System Leaflets: HEX-2 and HEX-3. Both the end bell and the cap was abrasive blasted to a near white metal finish with an angular profile of 3 mills. Belzona 1511 was used to rebuild the steel substrate for high conditions Belzona 1391T to protect the steel substrate for high heat conditions.

The Customer needed to prolong the service life of a heat exchanger. The alternative was to purchase a new end cap and end Bell for the heat exchanger unit due to it leaking on the sides during operation. The cost-effective solution was to rebuild it with Belzona 1511 and protect it with Belzona 1391T protection system against high heat operation. This long lasting solution has saved the Customer downtime and money for future operation costs.
