# Belzona Rebuilds and Protects a Clarifier

ID: 7816

**Industry:** Water / Wastewater  
**Application:** TCC-Tanks and Chemical Containment Areas  
**Substrate:** Concrete and Mild Steel  
**Products:** \* Belzona 4111 (Magma-Quartz),  
\* Belzona 5811 (Immersion Grade),  
\* Belzona 5111 (Ceramic Cladding),

**Customer Location:** France  
**Application Date:** November 2018

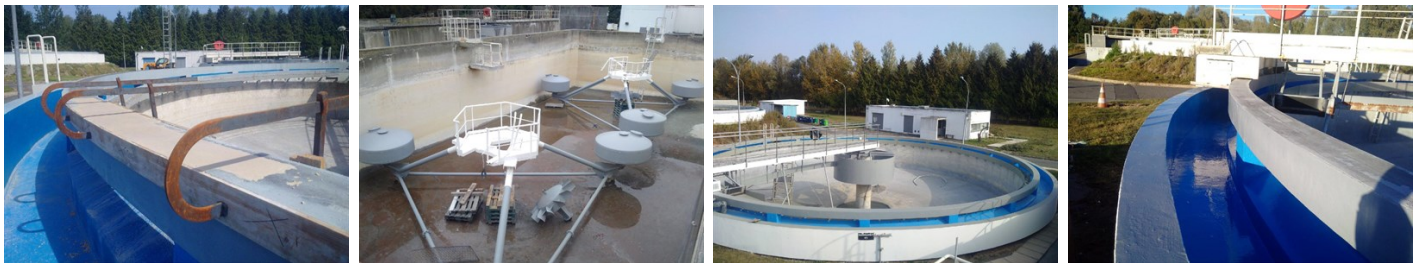
The concrete roller track of this clarifier became damaged during operation and needed to be rebuilt. The floats and turbines had begun to corrode, so required protection from further deterioration.

- \* Concrete repair on the roller track with Belzona 4111 and a former. ,
- \* Protection of the tripods, turbines and floats with Belzona 5811. ,
- \* Final application. ,
- \* Close up view of final application. ,

The broken parts of concrete on the roller track were taken away and the surface of both the track and the clarifier trough were prepared by scarification. Metal components were prepared by grit blasting. After the surface preparation, the concrete was rebuilt using Belzona 4111 with a trowel and a former when needed, in accordance with a modified version of Belzona Know-How System Leaflet TCC-09. The trough next to the roller track was protected with Belzona 5111. The floats and turbines were protected with Belzona 5811.
