# 1000/700 ALLEN GWYNNE PUMP PROTECTED WITH BELZONA

Industry: *Water / Wastewater*  
Application: *CEP-Centrifugal Pumps*  
Substrate: *Cast Iron*  
Products: *Belzona® 1341 (Supermetalglide)*

Customer Location: *Local water authority - South Africa*  
Application Date: *July 2006*

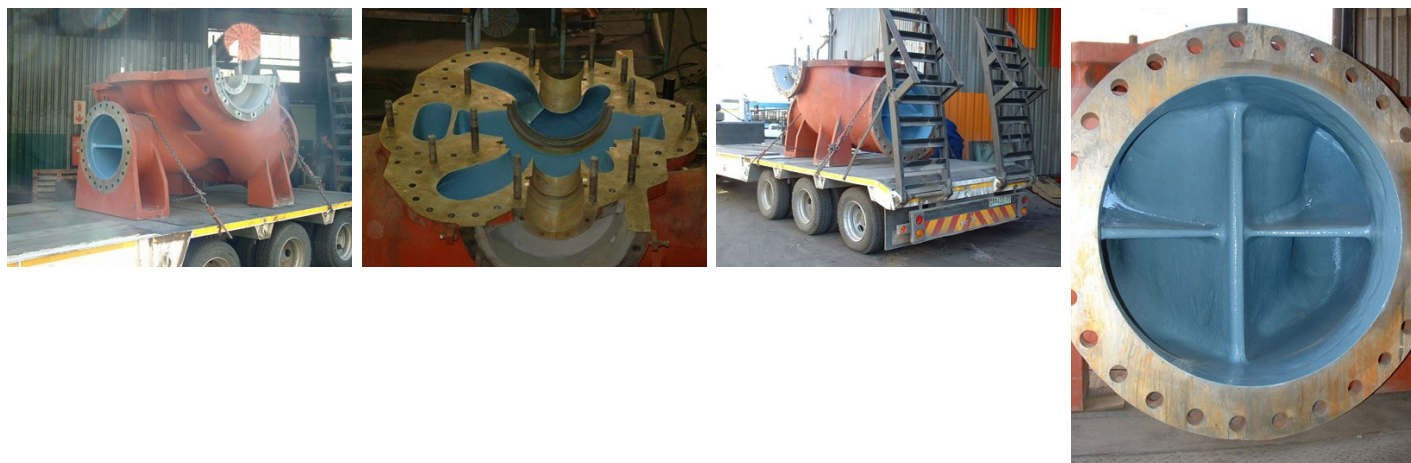
## Photograph Descriptions

*Pump required coating to reduce corrosion and improve efficiency.*

\* Pump being delivered to OEM after coating. , \* Pump internals , \* 9 ton bottom Section , \* Pump suction ,

12 ton water distribution pump.

Application was carried out in accordance with Belzona System leaflet CEP-10

40 Kg of Belzona® 1341 were applied to this pump. This water authority has standardized on Belzona® 1341 for all their water pumps.
