Corroded Weighing Bridge Repaired and Protected

ID: 7870

Weighbridge checker plate at a petrochemical plant, LPG/Gas Terminal.

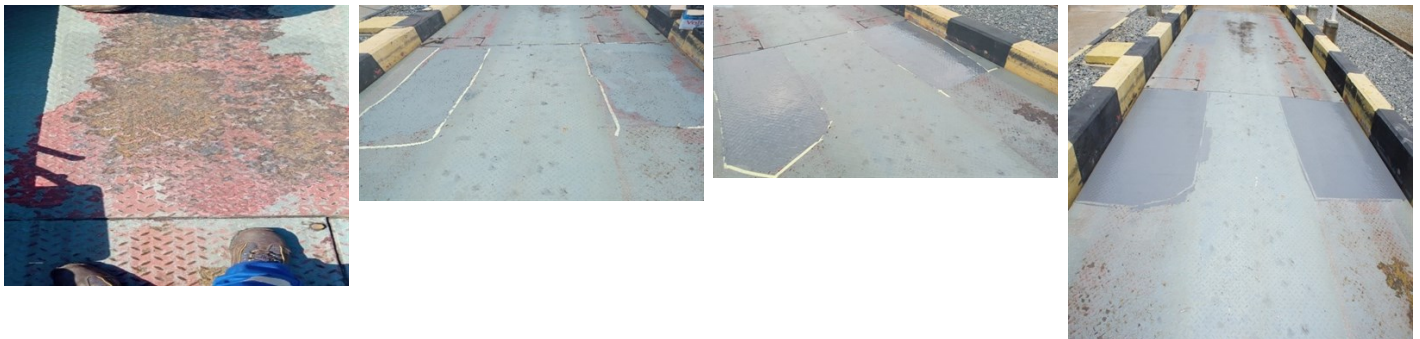
Photograph Descriptions

The Customer had an existing weighbridge to determine the amount of Liquefied Petroleum Gas (LPG) leaving the plant on trucks, the corroded weighbridge undermines the accuracy of the data derived from the weighbridge. The worn out surface of the weighbridge was also a safety issue, the Customer has used other surface protection products that failed within a very short period so they opted for Belzona solutions because of the proven durability.

- * Corroded surface of the weigh bridge Original weighbridge. ,
- * During application on the weighbridge checker plate. ,
- * Belzona 1111 being applied to rebuild lost metal. ,
- * Belzona 5231 being applied to prevent further wear and corrosion. ,

Application was carried out in accordance with a modified version of Belzona System Leaflet FPA-3 for protecting floors and drains against chemical attack. Belzona 1111 was applied to rebuild the lost metal after surface was blasted with Bristle Blaster. Belzona 5231 was then applied as a heavy-duty protective coating and to protect against further corrosion.
