# Belzona has what it takes to stop the acid leak

ID: 7911

Industry: Chemical & Petrochemical  
Application: VPF-Valves, Pipes and Fittings  
Substrate: Steel  
Products: \* Belzona 4301 ( Magma CR1 Hi-Build ),

Customer Location: Huelva - Spain  
Application Date: June 2018

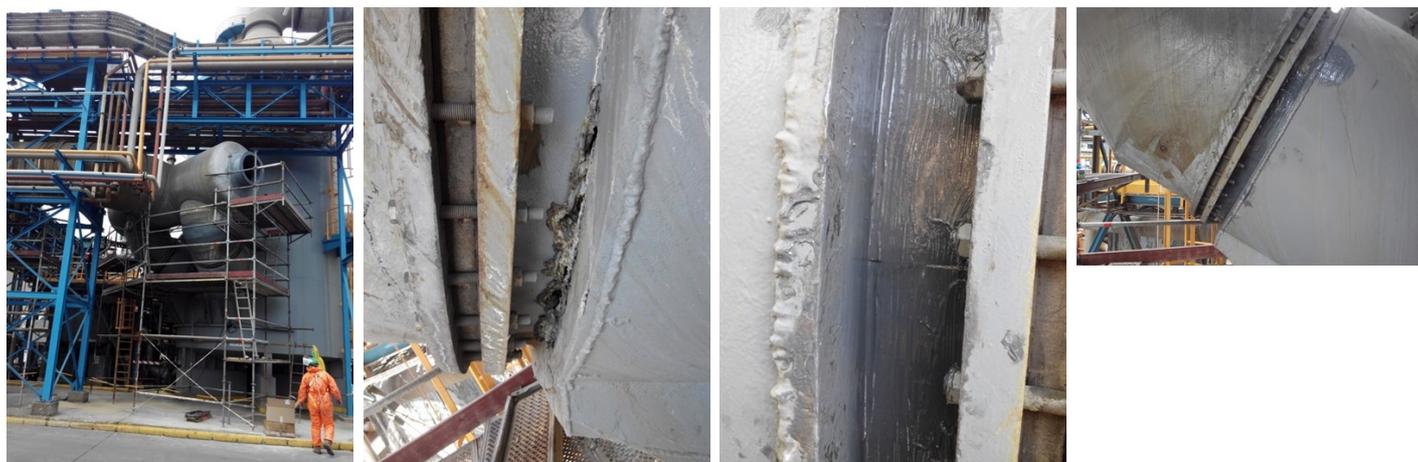
## Photograph Descriptions

*In the gas suction line condensation of the acids on the internal surface has caused severe corrosion, leading to leaks, which are hazardous to the surrounding environment.*

- \* 1. Location of equipment within the acid plant ,
- \* 2. Close up of defect ,
- \* 3. Belzona 4301 being applied ,
- \* 4. Completed repair ,

The damage is localized to a small area on a large section of pipework. Replacing is a costly and work intensive exercise. Weld repairs are likely to lead to the same problem occurring again. Access for heavy welding equipment is also difficult, and hot work is

Application is carried out using a modified version of Belzona System Leaflet VPF-11. The surface was prepared using mechanical tools and was cleaned with acetone to remove surface contaminants.

not permitted without special measures being put in place, which are undesirable to the customer. Belzona 4301 has the required chemical resistance to stand up to the 98% sulfuric acid, and can be applied quickly and easily, making it a convenient and effective solution.
