Belzona PROVIDES LEVEL SURFACE ON A WALKING FLOOR

ID: 7919

Customer Location: *Power plant, UK*
Application Date: *March 2019*

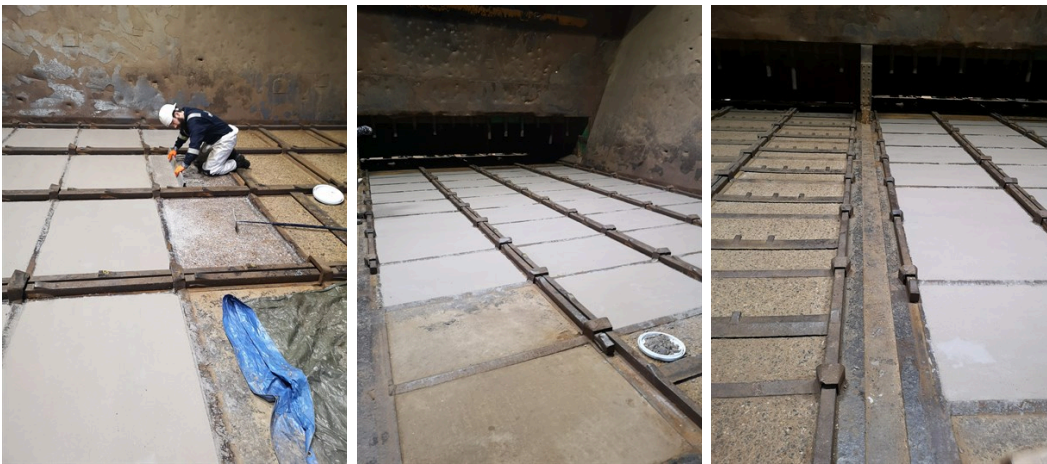
The wood chippings are brought to the area by using large machinery weighing up to 24 ton. Drag chains are also used in the process. These actions are believed to of damaged the concrete floor and eroded a large amount of surface concrete away. so we offered a solution to repair a trial area and increase abrasion resistance.

- * 1- Application of the test area of Belzona 4131 ,
- * 2 - Completed Trial Application ,
- * 3 - Completed Trial Application (2nd View) ,
- * 4 - Completed full repair. ,

Application took place on a section of flooring within the 'Walking Floor Area' which has become damaged over the years. The Walking Floor Area is used to store and process wood chippings before dropping down onto a conveyor system.

The Belzona 4131 system was applied using the existing channel rails as a datum for depth and finish. The average depth was estimated to be 18mm. This application was completed in accordance with Belzona Know-How System Leaflet FPA-01.
