BELZONA BONDS FRAMEWORK TO OILRIG DECK

Industry: Oil & Gas
Application: GSS-Gaskets, Seals and Shims
Substrate: Carbon steel
Products: * Belzona® 5811 (Immersion Grade) ,

Customer Location: Norwegian Oil Operator
Application Date: January 2004

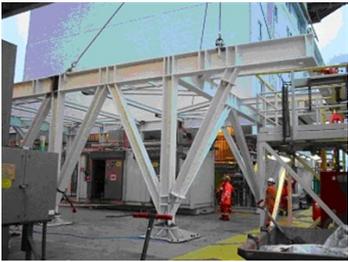
- * Lowering of sub frame into position and alignment. ,
- * Bonding application completed. ,
- * Accommodation Modules in position. ,

The application was carried out in accordance with a modified version of Belzona Know-How System Leaflet GSS-9.

Due to the extended time after alignment/sealing to the bonding phase nitrogen was used to prevent flash rusting in the void to be filled with the Belzona® 5811. To combat the very cold conditions in the North Sea, January (0°C) heat blankets were used to allow

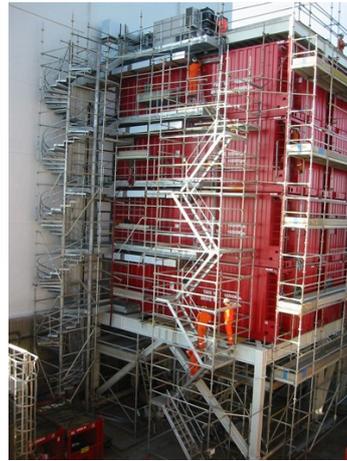
Module in place for 9 years weighing around 145 tonnes.
