Belzona Repairs Cement Plants Rotary Dryer

ID: 7930

Internal deterioration of a dryer shell at a cement plant.

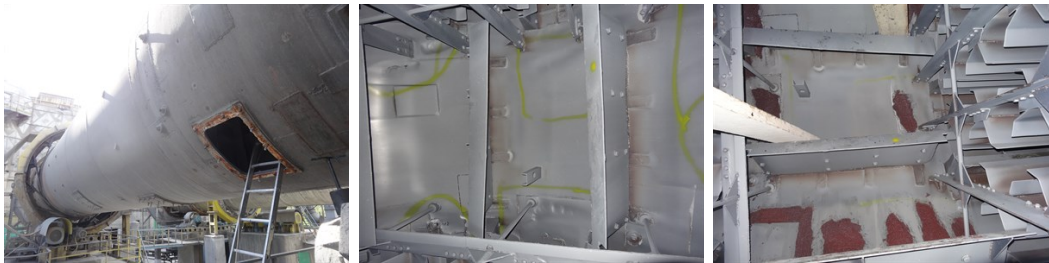
Photograph Descriptions

The rotary dryer (15 m long and 3.6 m diameter) is used for slag drying. The drying cylinder has an angle against the horizontal level and rotates while running. After putting the slag into one end of the rotary dryer, the slag is dispersed uniformly and forms a material curtain in the cylinder to contact the hot air (100°C), which acts like a heat exchanger to achieve slag drying. In the area where the lifting flights are installed onto the interior of the dryer, the slag erodes the steel, eating away up to 15 mm of the metal from the original 20 mm thickness of the shell.

- * 1. Entrance to the dryer ,
- * 2. The view of the eroded area ,
- * 3. The eroded areas rebuilt with Belzona 1811 ,

After proper surface preparation, the application was carried out in accordance with a modified version of Belzona Know-How System Leaflet SHM-13. ☐ Belzona 1811 was used to fill in eroded small areas.

The customer stated that the Belzona repair material was much less costly than replacing the shell and importantly the application was completed within one day. The application was recently inspected (2019) and the original Belzona 1811 was in the same condition as the day the application was completed, more than 18 months prior. As a result, the customer asked Belzona for several
