BELZONA PROVIDES SEA WATER FILTER PROTECTION

ID: 794

Customer Location: Denmark, Danish Oil Operator
Application Date: Various since 2003

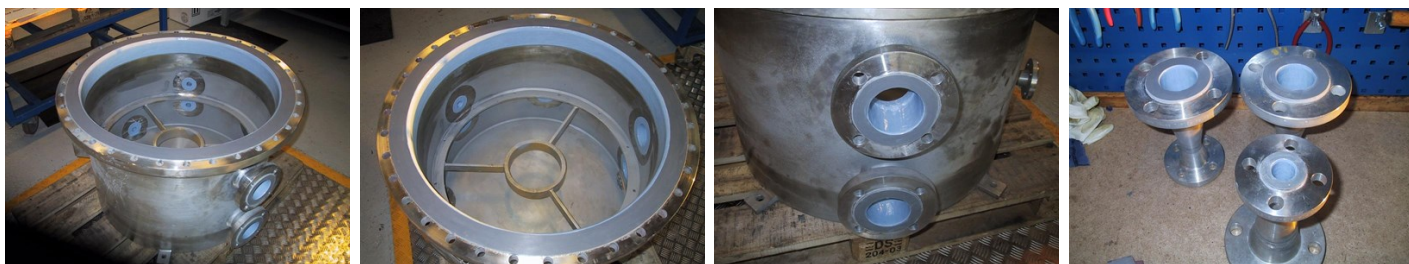
Photograph Descriptions

Conventional coatings were failing around the sealing faces and nozzle areas.

- * Main body of filter ,
- * Vertical view showing protected flange faces ,
- * Exit nozzle coating ,
- * Individual small bore nozzle coating ,

The application was carried out using a combination of Belzona Know-How System Leaflets TCC-3 and VPF-13.
