LANDING CRAFT WATER JET NOZZLES PROTECTED BY BELZONA

ID: 7995

Industry: Marine
Application: SOS-Ships and Offshore Structures

Customer Location: Cadiz - Spain
Application Date: October 2018

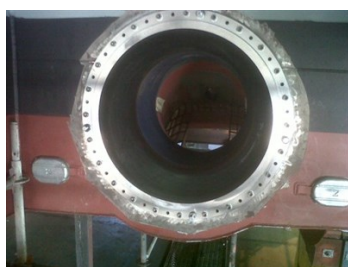
- * 1. View of the vessel hull ,
- * 2. Surface prepared, and Belzona 1321 (Ceramic S-Metal) applied ,
- * 3. Belzona 1812 (Ceramic Carbide FP) applied ,
- * 4. Completed Application ,

The stainless steel nozzles were machined to leave a rough profile to maximise the adhesion of the Belzona materials. Where the nozzles connect with the hull, grit blasting was carried out to achieve a white metal finish in accordance with Swedish Standard SA 3. Belzona 1321 (Ceramic S-Metal) was applied to the surface entire surface by brush. Belzona 1812 (Ceramic Carbide FP) was applied in the areas subject to high impact and abrasion. A final layer of Belzona 1321 was applied over the entire area to leave a smooth surface. The application was carried out in accordance with a modified version of Belzona System Leaflet SOS-02.
