# LANDING CRAFT WATER JET NOZZLES PROTECTED BY BELZONA

ID: 7995

Industry: Marine  
Application: SOS-Ships and Offshore Structures

Customer Location: Cadiz - Spain  
Application Date: October 2018

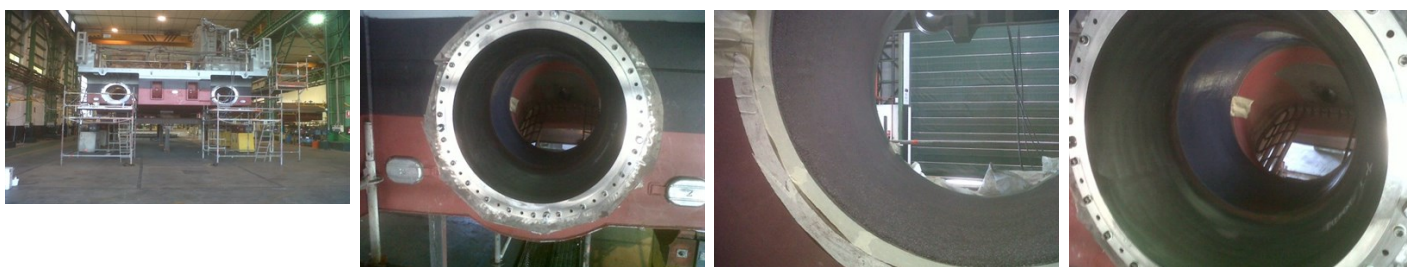
High flow rate, salt from sea water, and entrained solids cause accelerated wear of the water jet nozzles, therefore a protective system was required.

- \* 1. View of the vessel hull ,
- \* 2. Surface prepared, and Belzona 1321 (Ceramic S-Metal) applied ,
- \* 3. Belzona 1812 (Ceramic Carbide FP) applied ,
- \* 4. Completed Application ,

Stainless Steel water jet nozzles on a naval landing craft in dry dock.

The stainless steel nozzles were machined to leave a rough profile to maximise the adhesion of the Belzona materials. Where the nozzles connect with the hull, grit blasting was carried out to achieve a white metal finish in accordance with Swedish Standard SA 3. Belzona 1321 (Ceramic S-Metal) was applied to the surface entire surface by brush. Belzona 1812 (Ceramic Carbide FP) was applied in the areas subject to high impact and abrasion. A final layer of Belzona 1321 was applied over the entire area to leave a smooth surface. The application was carried out in accordance with a modified version of Belzona System Leaflet SOS-02.

Belzona was chosen over alternative materials due to the extensive range of Belzona products, which allowed the customer to select the most appropriate material for each section of the nozzle. At the inlet section, very high abrasion resistance was needed,

as this is where most of the stones and entrained solids impact the surface. However at the trailing edge of the nozzle, the conditions are not a severe, therefore cost can be saved by selecting the right material.
