# Belzona Repairs and Protects a Concrete Clarifier

ID: 8017

Application: FPA-Floor Problem Areas

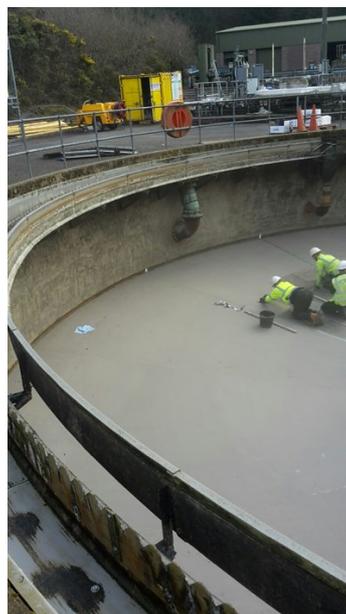
Placing screed rails

Belzona 4131 application by float

Application underway

The application was carried out in accordance with a modified version of Belzona KNow-How System Leaflet FPA-1. The concrete was first power washed and prepared mechanically. The clarifier was marked out into sections. Each section was then conditioned with Belzona 4911 and then 6mm of Belzona 4131 applied.

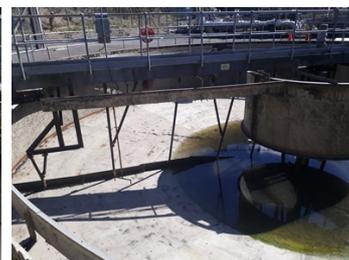
The tank drained one year on

mechanical strength and chemical resistance the original concrete. The tank was drained for a shutdown in May 2019 & found to be in a perfect condition.
