# Belzona Concrete Tank Repair

ID: 8033

Customer Location: Lisbon  
Application Date: April 2019

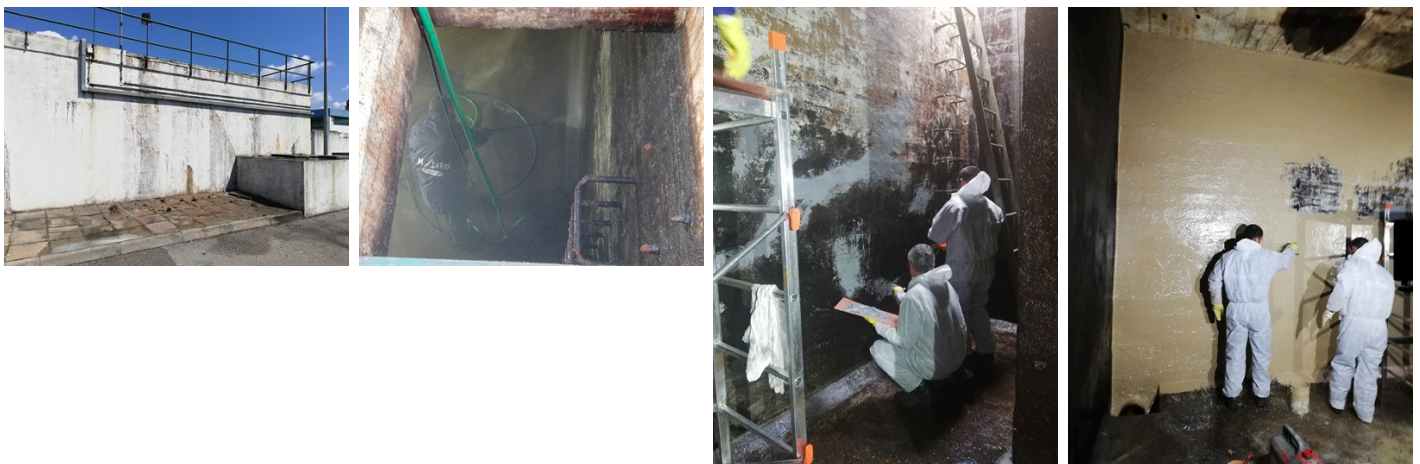
A large concrete tank used for supplying potable water for 3 of the neighboring cities was severely damaged internally. The cracked concrete was causing water to leak out of the external wall of the tank onto the road.

- \* 1. External view of the concrete tanks ,
- \* 2. Pressure washing/cleaning the concrete ,
- \* 3. Filling in the damaged concrete with Belzona 1161 ,
- \* 4. Coating of Belzona 5831 ,

The concrete tanks were pressure washed to get rid of any loose bits of concrete and to clean the tank walls before coating. As parts of the concrete walls were severely cracked, Belzona 1161 was used to fill in the damaged area. Finally Belzona 5831 was chosen to be applied onto the damp concrete as it is a product that cures in immersion.
