Belzona Batch Mixer Lining

ID: 8089

Industry: Food & Drink
Application: VPF-Valves, Pipes and Fittings
Substrate: Steel
Products: * Belzona 1321 (Ceramic S-Metal) ,

Customer Location: Flintshire, United Kingdom
Application Date: February 2019

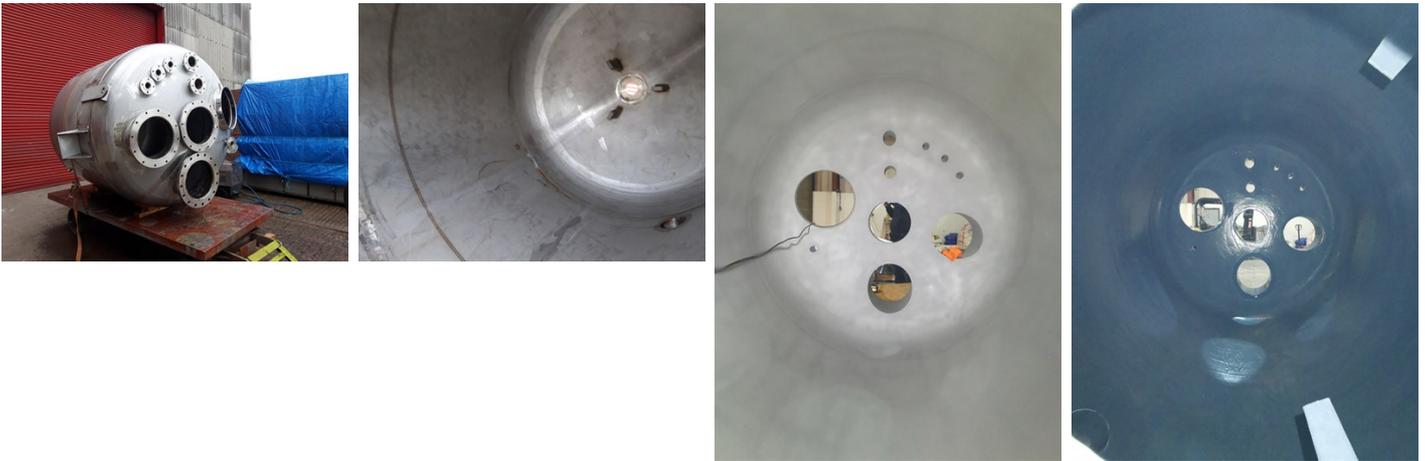
Photograph Descriptions

- * 1. The vessel being transported into the Belzona Technosol workshop, ready for work to begin. ,
- * 2. The inside of the vessel before being cleaned and blasted, ready for the coating. ,
- * 3. The first coating of Belzona 1321 Grey ,
- * 4. The finished application, after the second coating of Belzona 1321 Blue. ,

The vessel was grit blasted to SA2.5 at 75 μ , then lined with the first coat of Belzona 1321 to the required thickness, at the recommended coverage rate of (1.14 m²)/kg in accordance with Belzona Know How System Leaflet VPF-02. Due to the dimensions of the tank, a brush was used for the application. The second coat was then applied, and allowed to cure overnight.
