BELZONA PROTECTS HYDRAULICS ON WORLDS FIRST TIV

ID: 8139

Customer Location: Turbine Installation Vessel, Teesside, UK
Application Date: November 2019

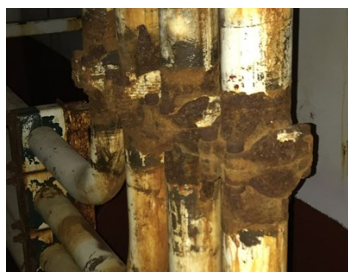
- * 1. Turbine Installation Vessel in action ,
- * 2. 78mm diameter hydraulic pipework ,
- * 3. First coat of Belzona 3412 in progress ,
- * 4. Peelable protection completed ,

The application was carried out in accordance with Belzona System Leaflet GSS-11. The Belzona 8411 was applied to release the areas of the fittings, before coating Belzona 3412 over the area and extending 125mm onto each side of the pipework.
