# Belzona lines an Air Receiver

ID: 8142

Customer Location: Danish sector of the North Sea

Application Date: November 2019

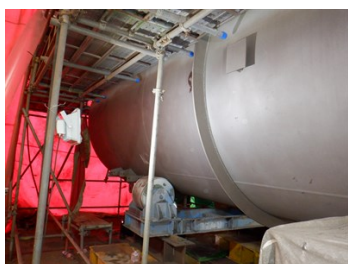
- \* 1 General View of Vessel ,
- \* 2 Vessel after grit blasting ,
- \* 3 Application underway ,
- \* 4 Application completed ,
