# MEDIA FILTERS PROTECTED WITH BELZONA

ID: 816

Industry: Water / Wastewater  
Application: TCC-Tanks and Chemical Containment Areas  
Substrate: Carbon steel  
Products: Belzona® 5811 (Immersion Grade)

Customer Location: Water treatment plant, Egypt  
Application Date: March 2006

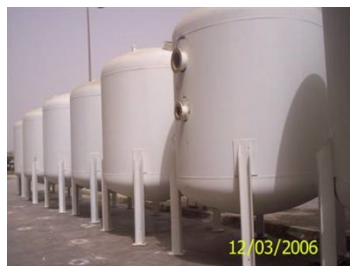
Filters were suffering internal corrosion and required protection to prevent further loss of wall thickness.

\* General view of the filters , \* Surface before preparation , \* Filter internals after coating , \* Covers were also protected ,

Application was carried out in accordance with Belzona Know-How System Leaflet TCC-3.

Belzona performed ultimate Long term protection to the filters. This is a typical Belzona immersion protection application.
