Chemical Resistant Belzona Lining Applied to Interior of Mixer Drum

ID: 8167

Customer Location: Chemical Manufacturer, Bristol, UK
Application Date: December 2018

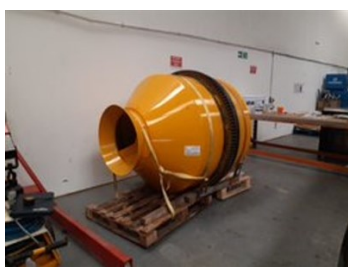
- * 1. Mixer drum delivered to workshop ,
- * 2. Internal substrate prepared ,
- * 3. Voids between blades filled ,
- * 4. Completed lining ,

Newly fabricated mixer drum (2.2m length x 1.5m diameter) used in a chemically aggressive process.
