# Protection of a brand new secondary containment area with Belzona

ID: 8170

Customer Location: Chemical Company - France  
Application Date: January 2020

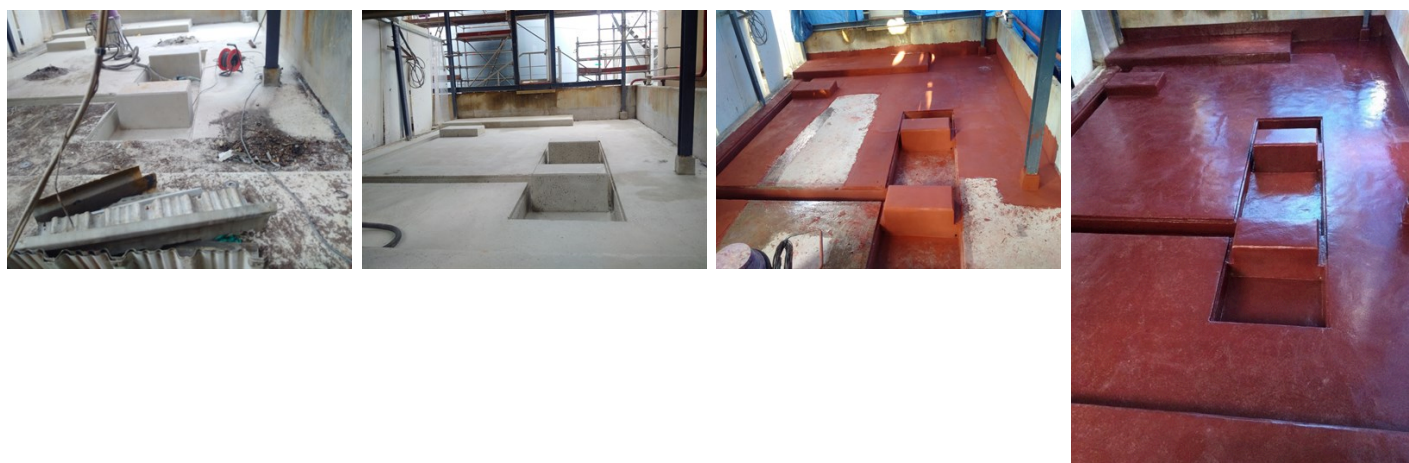
## Photograph Descriptions

- \* 1 - Secondary containment area newly created ,
- \* 2 - Area after surface preparation ,
- \* 3 - During the application ,
- \* 4 - Area completely coated and protected with Belzona 4181 ,

Brand new secondary containment area 216m2 where reactor pumps with hydrochloric acid at 80°C will be installed.

The area was cleaned and prepared before that the application of Belzona 4181 was completed in accordance with Belzona System Leaflet FPA-03.

Belzona 4181 had successfully passed all the client tests (especially the high temperature) for this plant where they produce synthetic salt. Area of 216 m2, carried out in 5 days for a 4 men team. Overall cost 74,000€.
