Acid mixing tank drip mitigated with Belzona

ID: 8183

Repair and protection of a concrete containment area in a brewery.

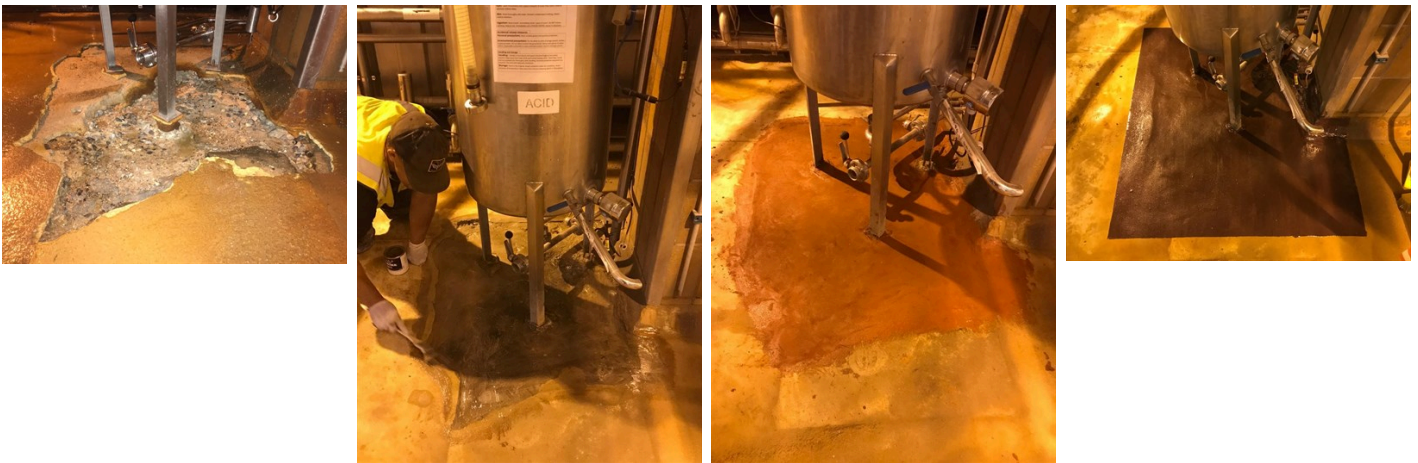
Photograph Descriptions

Regular dripping from the acid mixing tank was causing severe degradation to the concrete at the feet of the tank. The acid mixture had been absorbed into the concrete, threatening to damage the supporting structure.

* 1. Original condition of damaged concrete 2. Post cleaning, surface primer being applied 3. Concrete rebuilding 4. Complete application ,

The application was carried out in accordance with Belzona System Leaflet FPA-3. The concrete was washed repeatedly with Belzona 9111 (Cleaner Degreaser) to remove acid contamination from the concrete. The concrete surface was rebuilt using Belzona 4131 (Magma-Screed) and protected from further chemical attack with Belzona 4311 (Magma CR1).

The application was completed within 1 day, offering a significant reduction in downtime when compared with laying new concrete. The high chemical resistance of the Belzona 4311 (Magma CR1) top coat offers excellent resistance to the acid mixture, preventing further damage and reducing the future maintenance requirements.
