# Belzona® Cold Bonding Technology Prevents Pipe Vibration

ID: 8230

Customer Location: Petrochemical plant in Bohai, China  
Application Date: 2010

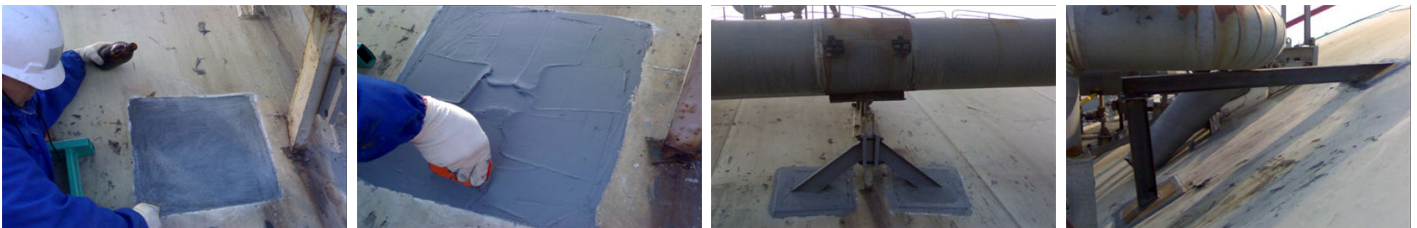
Pipelines of petrochemical storage tanks have been subject to vibration during loading and unloading. This problem is exacerbated by the increased frequency of loading and discharge, and the damage to the structure is also more serious. Therefore, an additional support frame is needed to solve this problem. However, due to safety restrictions, hot work is not allowed. In this case, the customer specifically chose Belzona's cold-bonded steel sheet as an additional support frame.

- \* 1. Surface preparation ,
- \* 2. Apply Belzona 1111 ,
- \* 3. Application complete ,
- \* 4. Appearance of tank roof pipeline ,

By installing additional supports on the tank roof, Belzona provides customers with an effective solution eliminating vibration of pipelines. Cold bonding technology avoids hot work. This application was completed in only 4 hours.
