Belzona coats a Hydro Power pump shaft

ID: 8235

Industry: Water / Wastewater
Application: MPT-Mechanical Power Transmission

Customer Location: Austria
Application Date: May 2019

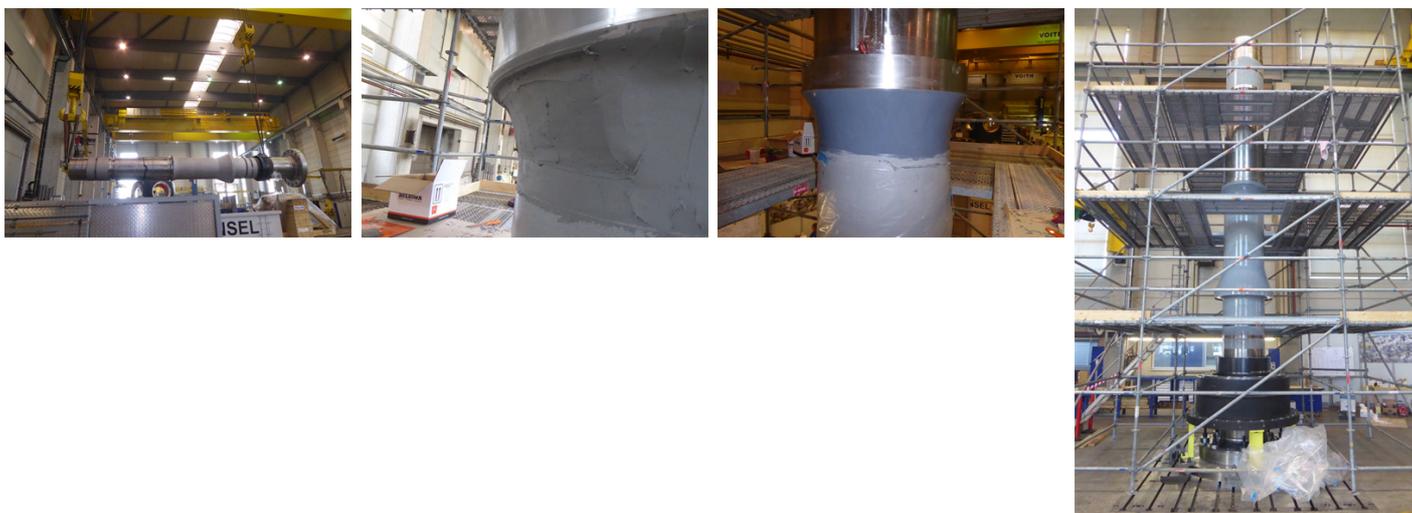
Conditions during operation: Head: 760 m, Power: 195 MW, Speed: 600 rpm Flow rate: 30 m³ / s. A slight increase in abrasion is to be expected within the new build.

In the course of a general refurbishment and performance increase of the pump, a new impeller was installed which changed the profile. This required a change in the contour of the shaft, which is where Belzona was required. The areas of the shaft in contact with water were coated with Belzona 5811.

The application was completed in accordance with Belzona System Leaflet MPT-01 and CEP-03.
