Belzona® SuperWrap II On-site Application for CUI

ID: 8241

Customer Location: Taicang, China
Application Date: January, 2017

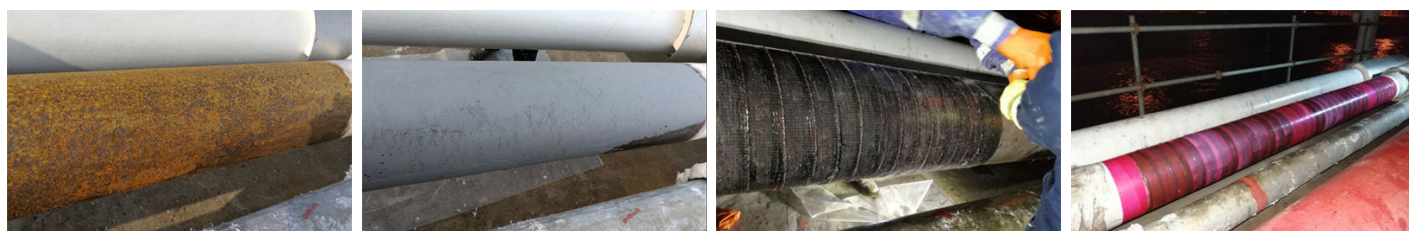
Photograph Descriptions

Corrosion under insulation(CUI).

* 1. Damaged pipelines before application 2. Repair pitting spots with Belzona 1111 3. Multiple layers applied in accordance with designing requirement 4. Application complete before release film removal. ,

Application carried out in accordance with Belzona System Leaflet VPF-11 using Belzona SuperWrap II technology with installers, supervisors and designers who had been fully validated trained with this system. The first step is rebuilding corroded area by using Belzona 1111 to restore the original profile of pipelines. Then use Belzona SuperWrap II to restore and improve the strength of pipelines.
