Belzona® Composite repair On-site Application for Buried Natural Gas Pipelines

ID: 8242

Application: VPF-Valves, Pipes and Fittings

Application Date: August, 2013

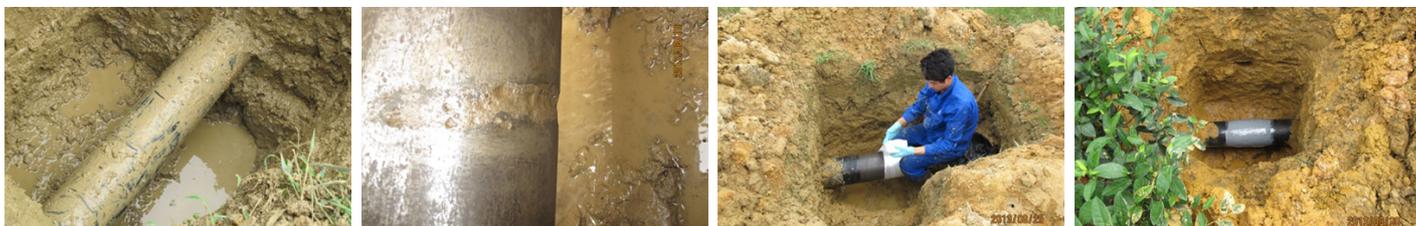
Photograph Descriptions

The operating pressure of these buried gas pipelines is 2Mpa; Maximum depth of external metal loss is 6.7mm; The corrosion area is 40 × 60mm. These pipelines have been immersed in a humid environment for a long time, and the surface of the pipeline cannot be dried.

- * 1. Buried pipeline☐ ,
- * 2. Damaged external surface☐ ,
- * 3. Dry wrapping of the reinforcing sheet; ,
- * 4. Application complete ,

Application carried out in accordance with Belzona System Leaflet VPF-11

As these buried gas pipelines operate in humid environments (such as paddy fields and hills area), Belzona moisture tolerant material is used for on-site application which avoids hot-work and saves time and costs for client. The client is very pleased with the result.
