Rubber lined ionization chamber repaired

ID: 8322

Application: SHM-Solids Handling Machinery

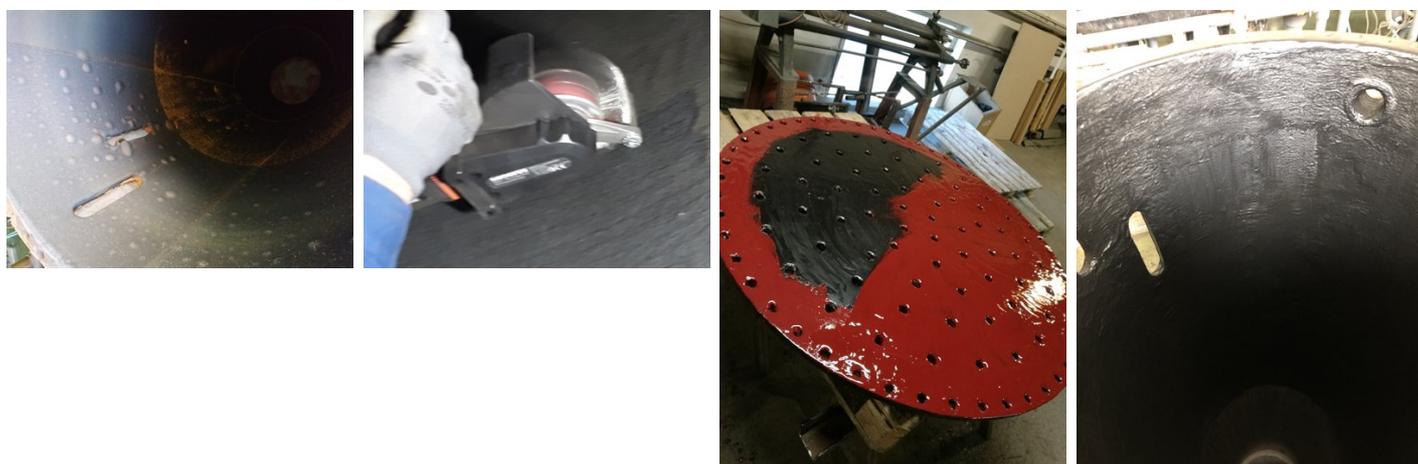
Photograph Descriptions

Damage of the original rubber lining of an ionization tower.

- * 1. Damaged rubber lining ,
- * 2. Removing of damaged lining and surface preparation ,
- * 3. Second layer of Belzona 2121 being applied ,
- * 4. Finished application ,

Damaged rubber lining has been removed and MBX was used to abrade the surface. Loosen rubber parts were cut off, Belzona 2111

was used to replace missing parts and Belzona 2121 was used to provide a long term and chemical resistant solution.
