Belzona distributor's oven helps quick return to service

ID: 8391

Industry: Chemical & Petrochemical
Application: HEX-Heat Exchangers
Substrate: Steel
Products: * Belzona 5892 ,

Customer Location: Petrochemical
Application Date: 2020

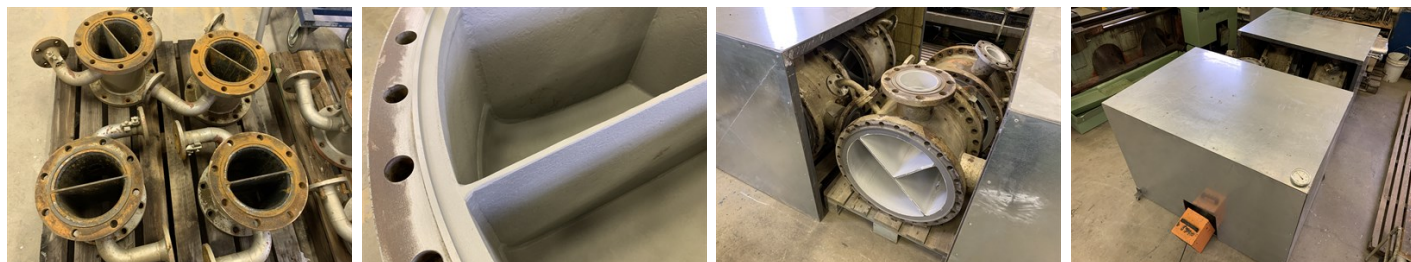
Photograph Descriptions

- * 1. Customer needed to protect his parts of exchangers ,
- * 2. After blasting and cleaning ,
- * 3. Parts of exchangers coated with Belzona 5892 ,
- * 4. Oven closing ,

After blasting and cleaning, the parts of exchangers were coated with Belzona 5892. The application was performed in accordance with Belzona system leaflet TCC-5. Distributor's own oven was used and the temperature raised so the coating was heated up to minimum 60°C for 1 hour.
