# Applying Belzona Coating For Internal Surface Of Media Filters

ID: 8406

Customer Location: *Egypt, Ain Sokhna*  
Application Date: *October 2020*

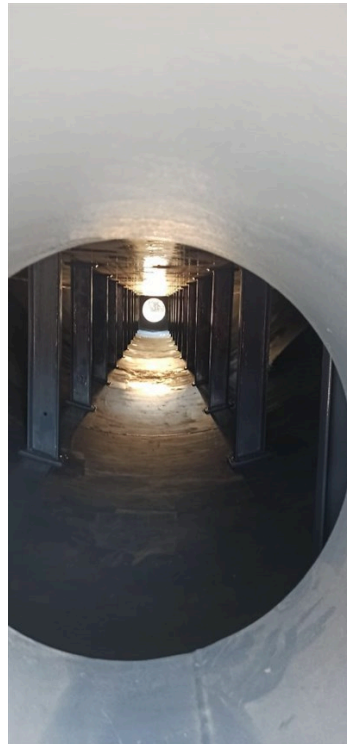
*Protect the media filters from erosion-corrosion*

- \* 1. General view of the filters. ,
- \* 2. Surface before preparation. ,
- \* 3. Filter internals after coating. ,
- \* 4. Accesories were also protected. ,

1-Grit blasting the surface to the Swedish standard (SA 2 1/2) to give surface profile not less than 75 microns. 2-All surfaces shall then be degreased using a suitable cleaner-degreaser, which does not have a residue, such as MEK Methyl Ethyl Ketone (Non-residue chemical cleaner). 3-Apply two coating system of Belzona 5821 with dry film thickness 500 microns.
