# Pharmaceutical Plant uses Belzona Safety Grip System

**Industry:** *Food & Drink*  
**Application:** *FPA-Floor Problem Areas*  
**Substrate:** *Concrete*  
**Products:** *\* Belzona 4111 (Magma Quartz) ,*  
*\* Belzona 5231 (SG Laminate) ,*  
*\* Belzona 1821 (Fluid Metal) ,*  
*\* Belzona 9211 (Supergrip Aggregate) ,*  
*\* Belzona 5233 ,*

**Customer Location:** *Switzerland*  
**Application Date:** *May 2020*

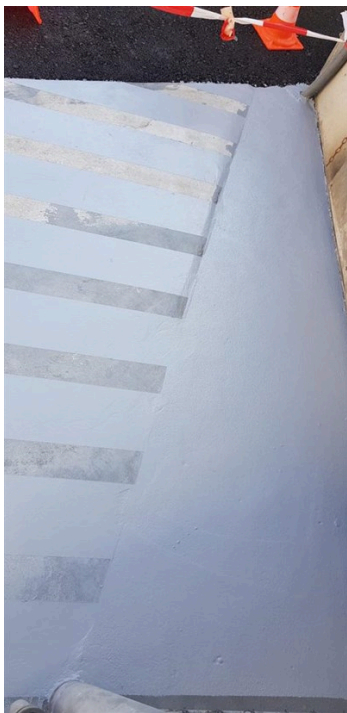
*The exterior flooring was an issue when the Pharmaceutical Plant forklift trucks were operating outside, causing the forklifts to slip when loading and un-loading.*

- \* Image 1: Application of Belzona 5231 ,
- \* Image 2: Strips of Belzona 5231 ,
- \* Image 3: Close up ,
- \* Image 4: Final Application Complete ,

Areas of concrete were repaired with Belzona 4111. The Belzona 5231 was applied in accordance with System leaflet FPA-8 to the concrete and then the Belzona 1821 and Belzona 9211 grip system was used to create a safety grip system then overcoated with Belzona 5233 for increased UV Stability.
