Belzona Lines High Temperature Ethanol Vessel

ID: 8449

Customer Location: Refinery, Scotland

Application Date: November 2020

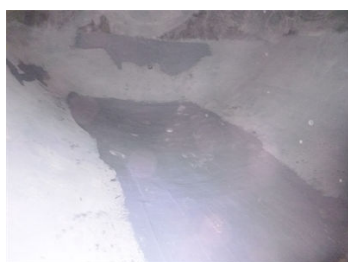
- * 1 - Vessel external ,
- * 2 - Belzona 1511 applied to areas of weld overlay ,
- * 3 - Belzona 1593 first coat ,
- * 4 - Belzona 1593 second coat ,
